INVESTIGATION NO. 2688
THE NORFOLK SOUTHERN RAILWAY COMPANY
REPORT IN RE ACCIDENT
NEAR FENTRESS, VA., ON
MARCH 29, 1943

Railroad: Norfolk Southern
Date: March 29, 1943
Location: Fentress, Va.
Kind of accident: Derailment
Train involved: Freight
Train number: 64
Engine number: 602
Consist: 32 cars, caboose
Estimated speed: 10 m. p. h.
Operation: Timetable and train orders
Track: Single; tangent; level
Weather: Clear
Time: 6:20 a. m.
Casualties: 1 killed; 2 injured
Cause: Accident caused by failure to provide adequate safeguards for movements approaching drawbridge, and by failure to obey stop signal
Recommendation: That the Norfolk Southern Railway Company provide adequate protection for movements over its drawbridges

Accident near Fentress, Va., on March 29, 1943, caused by failure to provide adequate safeguards for movements approaching a drawbridge, and by failure to obey a stop signal.

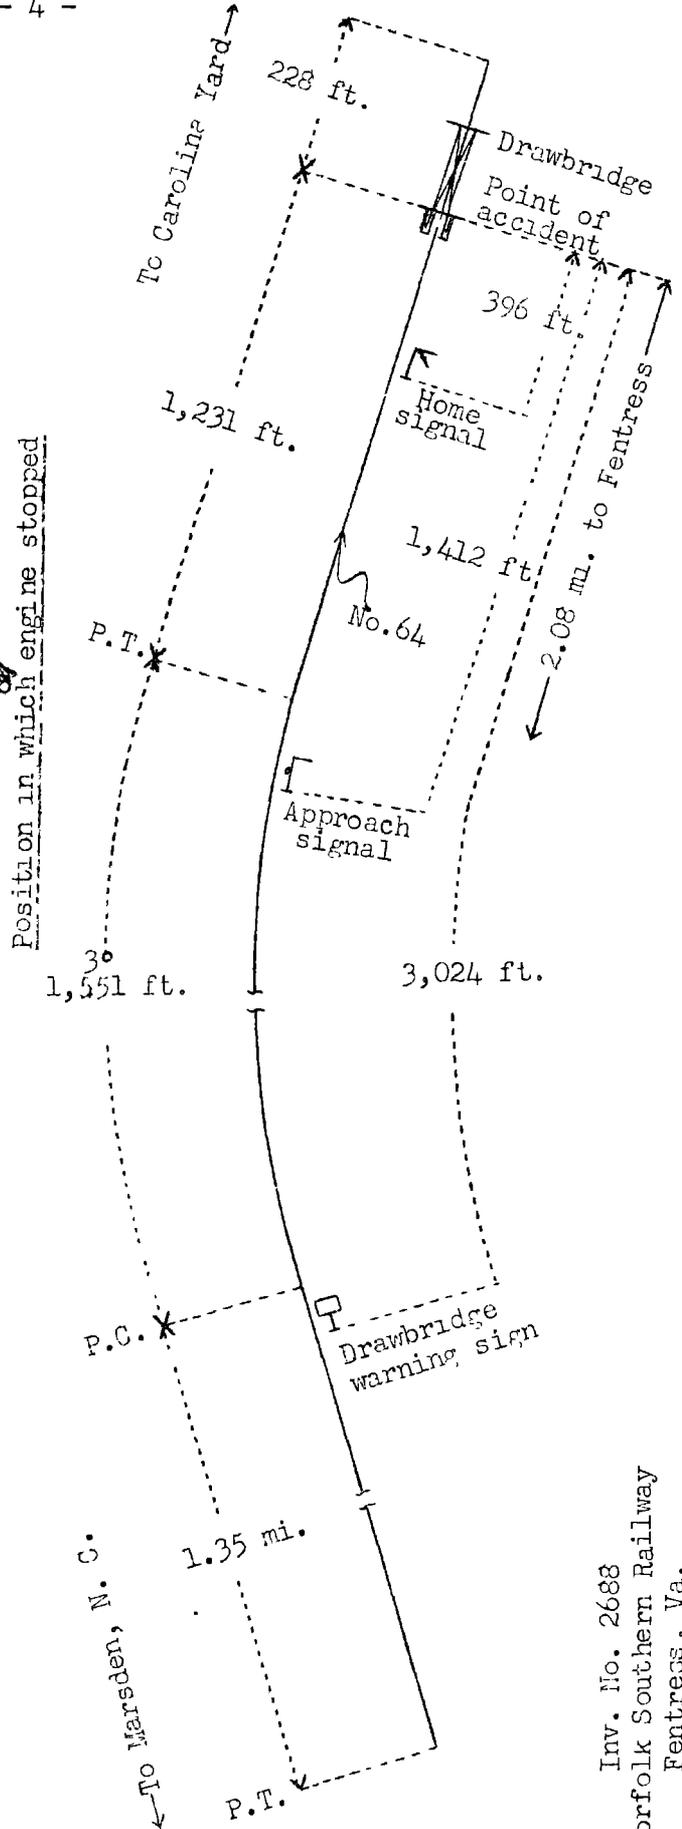
Inv. No. 2688
 Norfolk Southern Railway
 Fentress, Va.
 March 29, 1943

This accident occurred on that part of the Northern District extending between Marsden, N. C., and Carolina Yard, Va., 125.4 miles. In the vicinity of the point of accident this is a single-track line over which trains are operated by timetable and train orders. There is no block system in use. The accident occurred 2.08 miles north of the station at Fentress, Va., at a drawbridge which spans the Albemarle and Chesapeake Canal. Approaching from the south there are, in succession, a tangent 1.35 miles in length, a 3° curve to the right 1,551 feet and a tangent 1,231 feet to the south end of the drawbridge and 228 feet beyond. At the point of accident the grade is level.

The railroad crosses the canal at right angles. The draw-bridge is of the single-track, single-leaf, rolling bascule type. The fixed end is supported on two piers 37 feet and 63 feet 6 inches north of the south backwall. The distance from the south backwall to the north backwall is 195 feet. At each end of the draw-span there are deck-plate girder-spans 37 feet in length. The draw-span is 94 feet 6 inches in length and is operated by a gasoline engine. At the time of the accident the draw-span was open for traffic through the canal and was perpendicular to the track. The mean low level of the water under the draw-span was 11 feet 8-3/4 inches below the base of the rails and the water was approximately 15 feet deep. The drawbridge is equipped with a mechanical bridge-lock and self-aligning devices.

A warning sign, an approach signal and a home signal, governing north-bound movements, are located, respectively, 3,024, 1,412 and 396 feet south of the point of accident. The warning sign is rectangular in shape, 18 inches wide and 30 inches long, mounted on a post 6 feet high, and bears the words "3000 FEET TO DRAWBRIDGE" in black letters on a white background. The approach signal is of the one-arm, semaphore type, fixed in horizontal position and is oil lighted. The home signal is of the one-arm, two-position, lower-quadrant, semaphore type, and is oil lighted. The home signal and the bridge lock are operated by one lever, and are controlled from a drawbridge tender's cabin located on piling east of the draw-span and adjacent to its south end. The involved aspects and indications of these signals are as follows:

The engine stopped, badly damaged, upright and at an angle of 45 degrees to the plane of the track, with its front end and its rear end, respectively, 80 and 10 feet north of the fixed end of the draw-span. All of the engine except the cab was submerged. The tender remained coupled to the engine and stopped in the bridge opening with its rear truck on the fixed-end pier. The front end of the first car was considerably damaged.

It is recommended that the Norfolk Southern Railway Company provide adequate protection for movements over its drawbridges.
