REPORT OF THE DIRECTOR

ACCIDENT ON THE  
NORFOLK SOUTHERN RAILROAD

TIDEWATER JUNCTION, VA.

INVESTIGATION NO. 2414

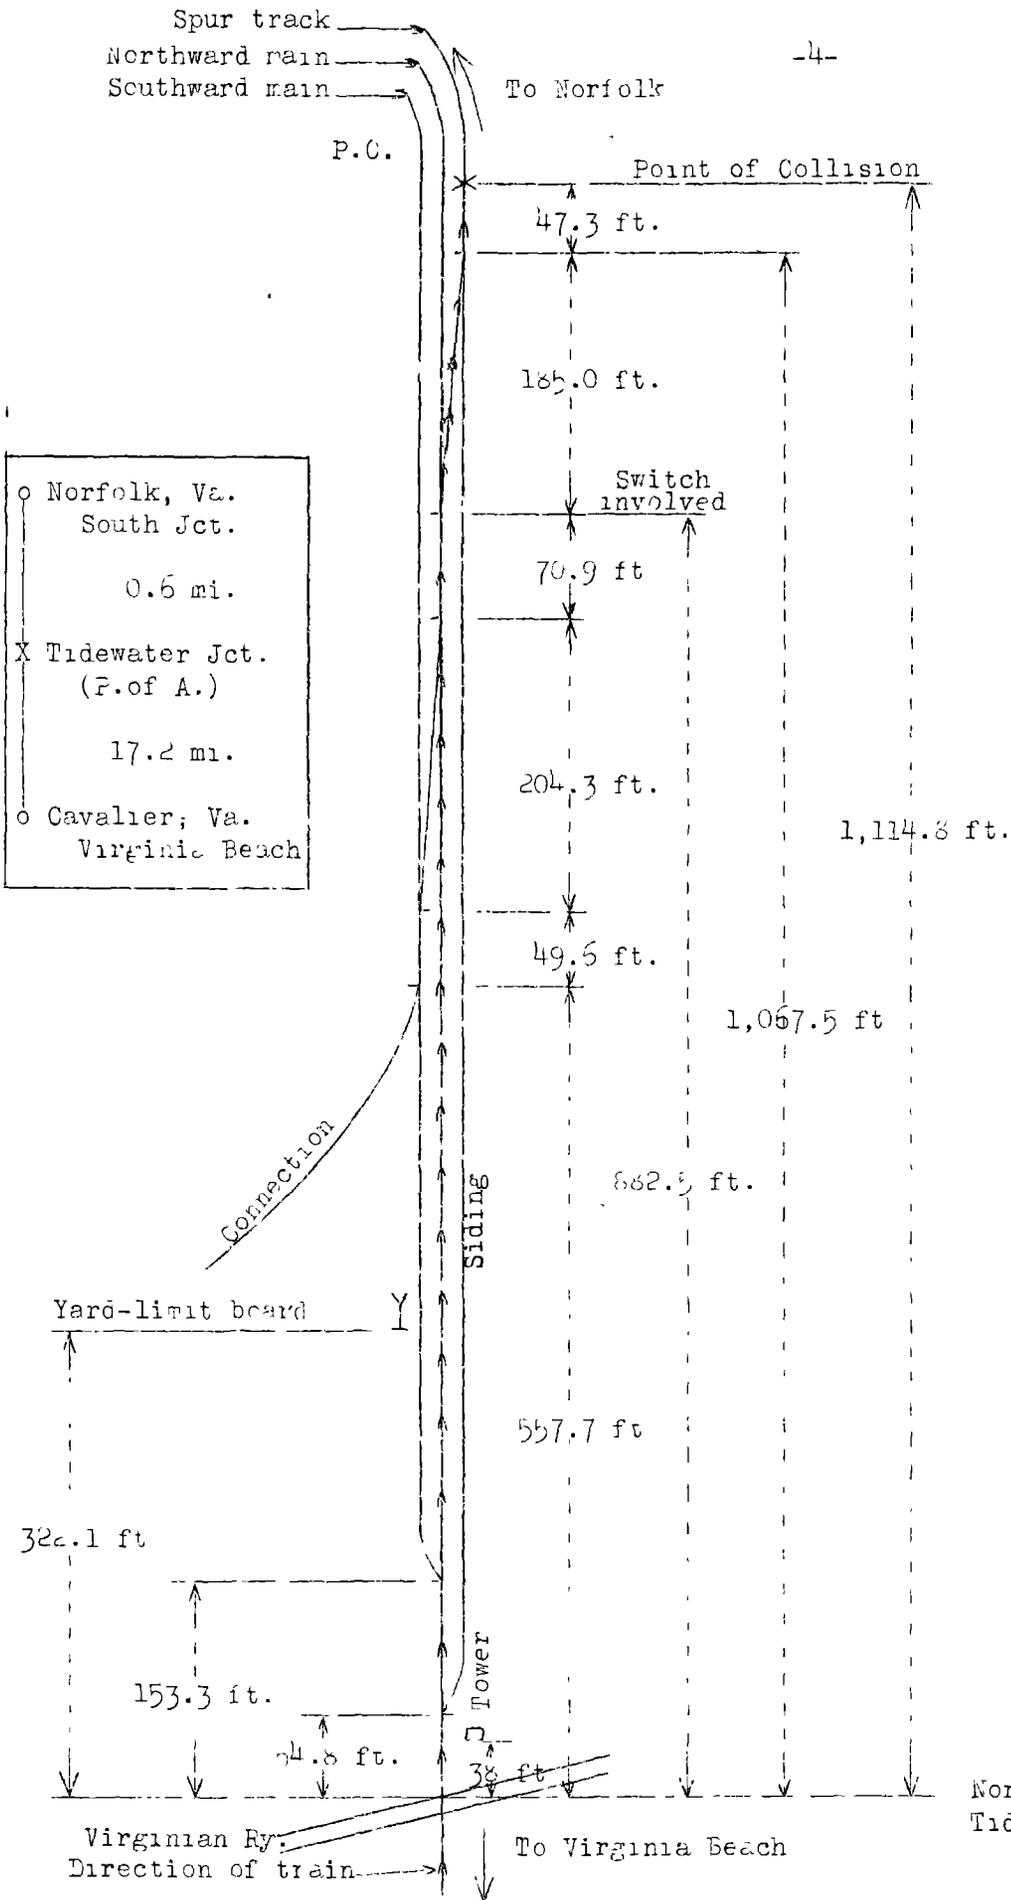
Inv. No. 2414  
 Norfolk Southern R.R.  
 Tidewater Junction, Va.  
 Feb. 12, 1940

o Norfolk, Va.  
 South Jct.  
 0.6 mi.  
 X Tidewater Jct.  
 (P. of A.)  
 17.2 mi.  
 o Cavalier, Va.  
 Virginia Beach

Approaching from the south the track is tangent 4,224 feet to the point of accident and 370 feet beyond. The grade is practically level. A double-track line of the Virginian Railway crosses the line of the Norfolk Southern Railroad at Tidewater Junction; movements over the crossing are controlled by interlocking. The interlocking is operated from a tower which is located in the northeast corner of the intersection and 38 feet north of the Virginian Railway tracks. On the Norfolk Southern Railroad the south end of the double track is 153.3 feet north of the crossing. A yard-limit board is located 322.1 feet north of the crossing. A siding, 1,012 feet in length, parallels the northward main track on the east and its south switch is 54.8 feet north of the crossing. A track joining the north end of the siding, extending northward and paralleling the northward main track is known as the spur track; the accident occurred at a point 47.3 feet north of the south end of this track. A facing-point cross-over for northward movements connects the northward main track and the spur track; the main-track switch and the spur-track switch are located 882.5 and 1,067.5 feet, respectively, north of the crossing. A cross-over, which is trailing for movements with the current of traffic, connects the northward and southward main tracks; its north switch is 70.9 feet south of the spur-track cross-over switch. A connection track between the Virginian Railway and the Norfolk Southern Railroad extends across the northwest corner; this track is connected to the southward main track at a point 557.7 feet north of the crossing and 49.6 feet south of

the south switch of the cross-over connecting the two main tracks. The cross-over switches to the spur track are hand operated, and all other switches mentioned are interlocked and operated from Tidewater Junction tower.
